# Miller Creek Greenway Concept Report

APPENDIX

B

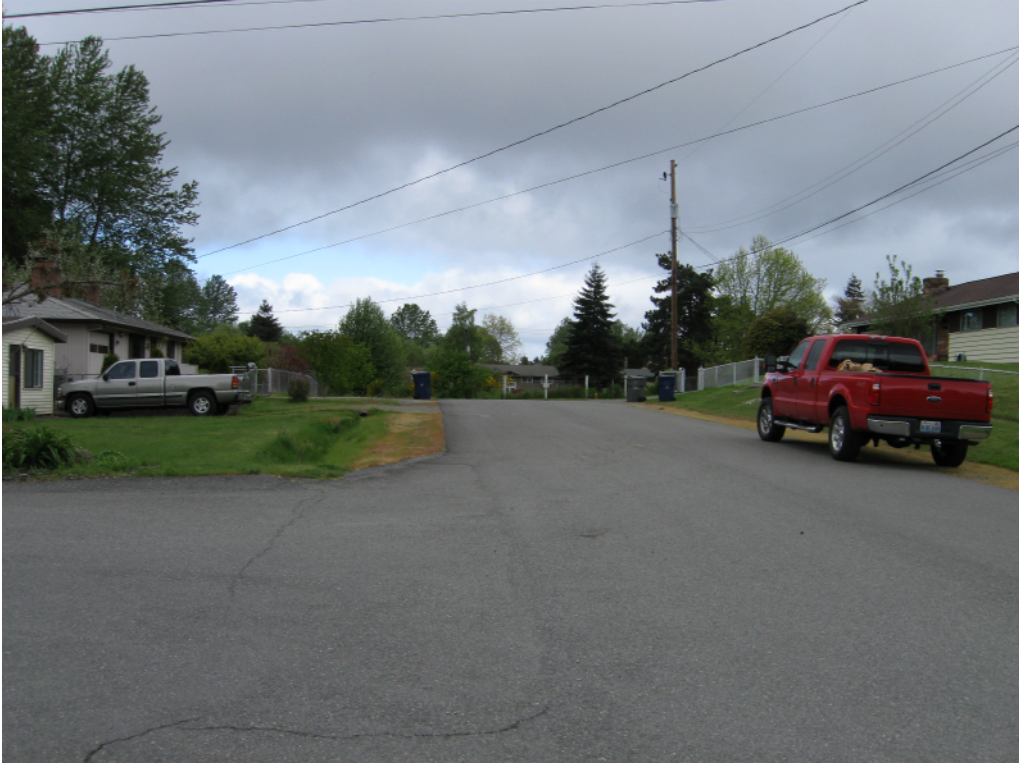
Photo ID: 006

Description: Roadside ditch and culverts. Piped drainage to vegetated ditches on 10<sup>th</sup> Ave. Between 137<sup>th</sup> and 138<sup>th</sup> Street, driveway culverts with ditches. Piped conveyance on East side of street.

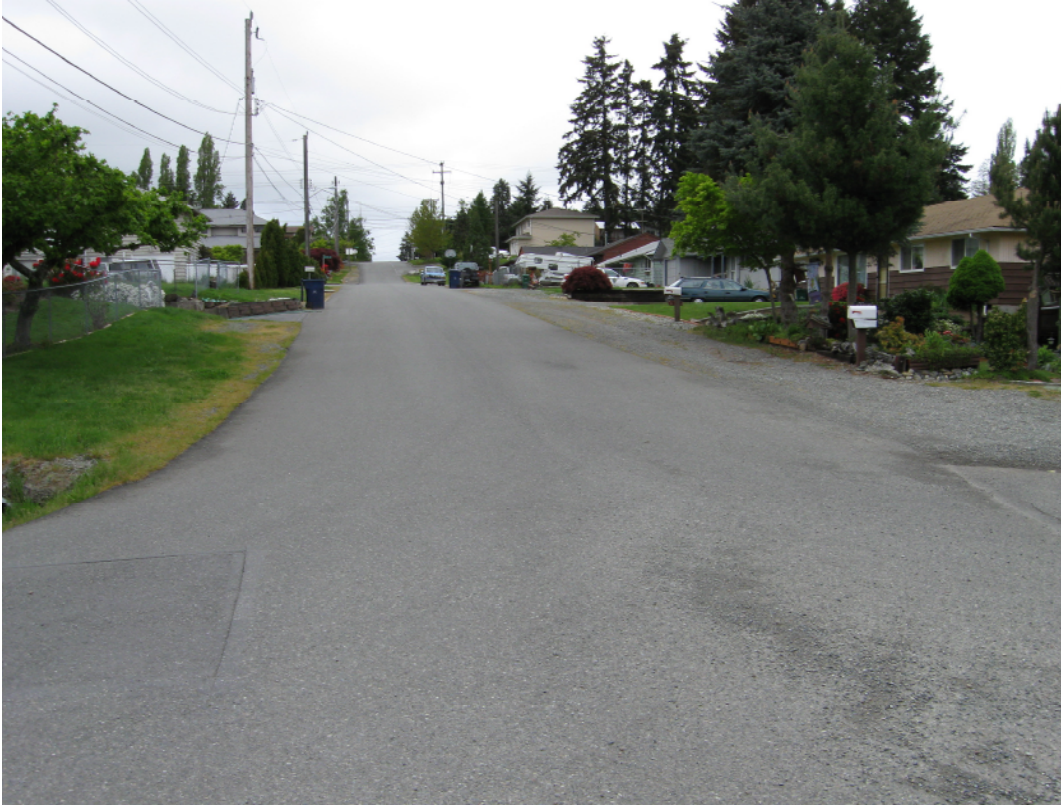
Photo ID: 011

Description: Ditched conveyance at 10<sup>th</sup> Ave.

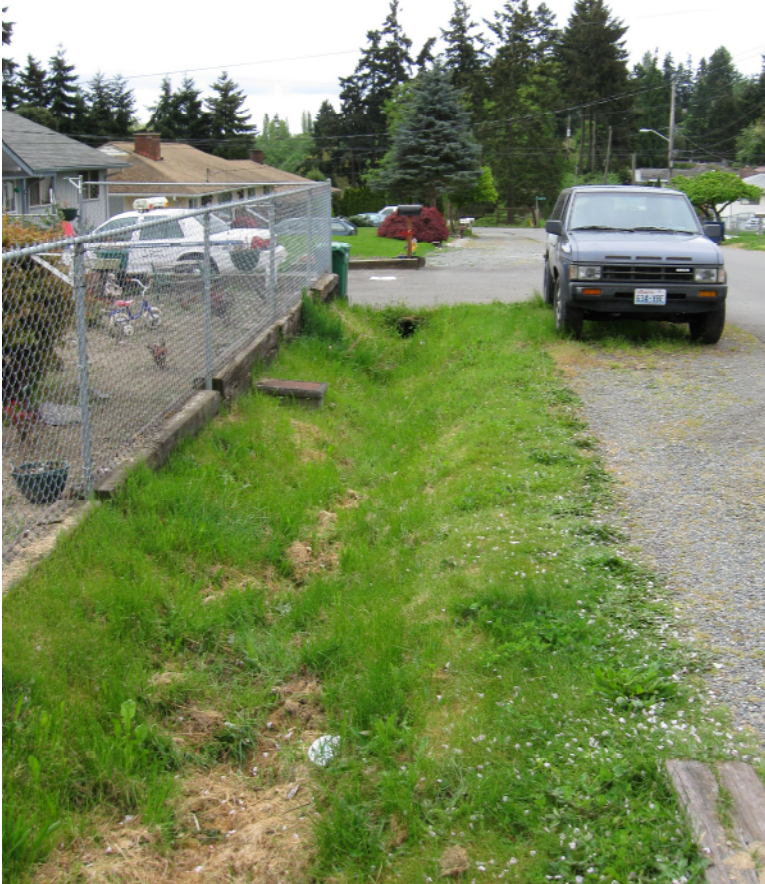
Photo ID: 015

Description: Ditch conveyance with driveway culverts on both sides of 10<sup>th</sup> Ave. Piped storm on west side of street.

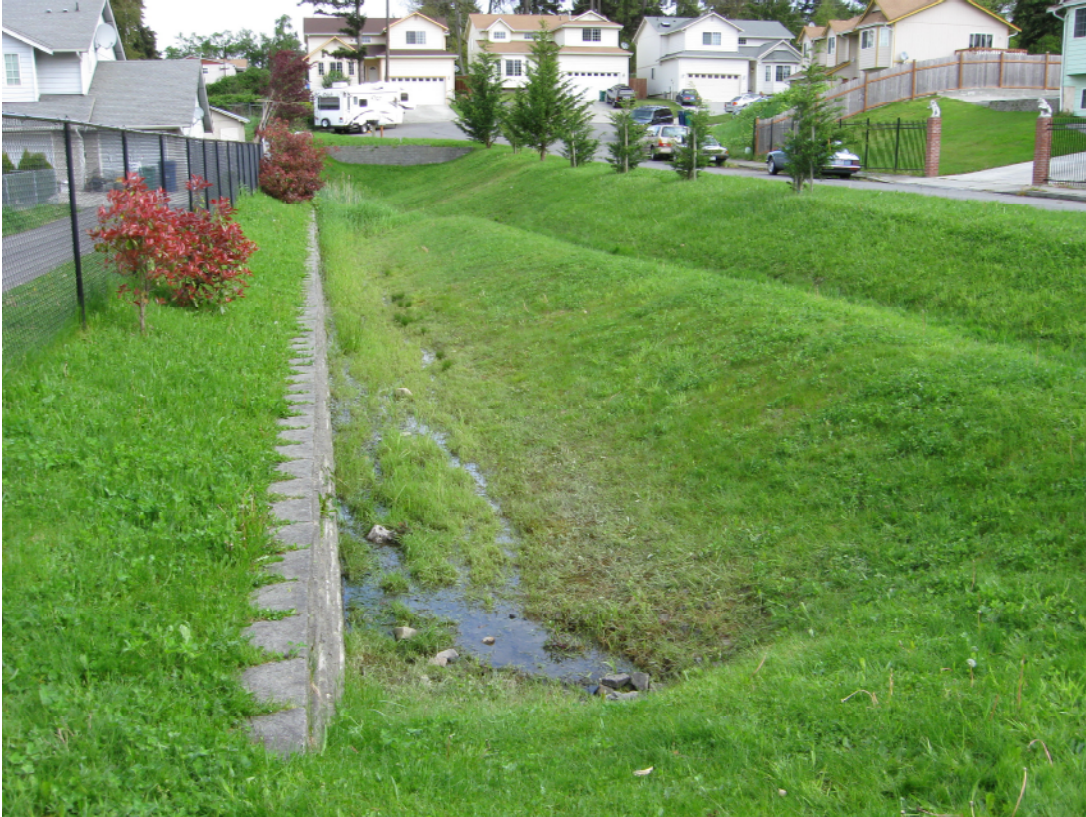
Photo ID: 022

Description: City of Burien Stormwater facility to reduce downstream flooding and improve water quality. Control structure located at SE corner.

Observations: Drains cul-de-sac development.

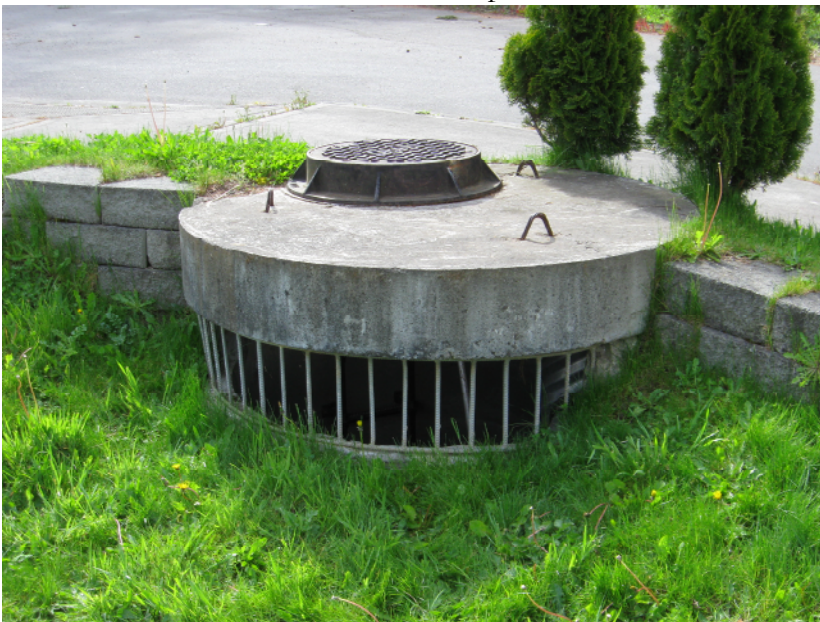
Photo ID: 024

Description: City of Burien Stormwater flow control structure with riser. This facility discharges on to the NERA project limits.

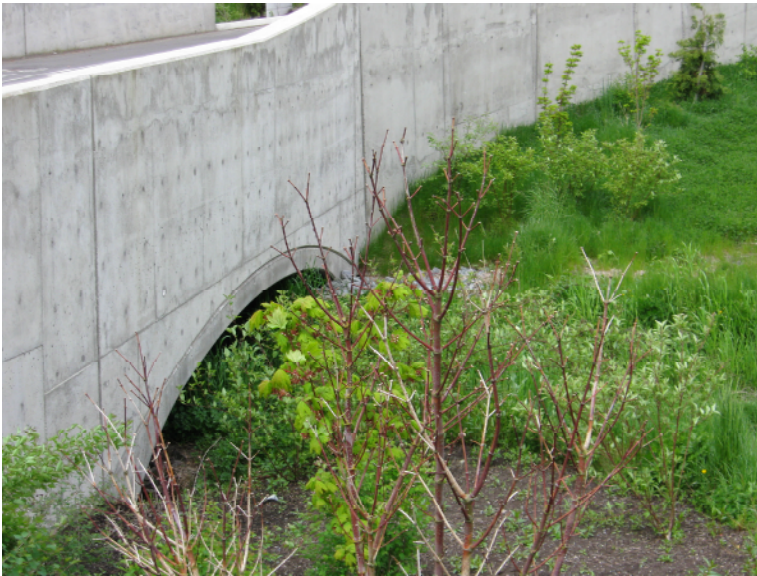
Photo ID: 030

Description: New arch culvert under a bridge for the new parking lot. The parking lot also has 2 Contech Stormwater treatment vaults.

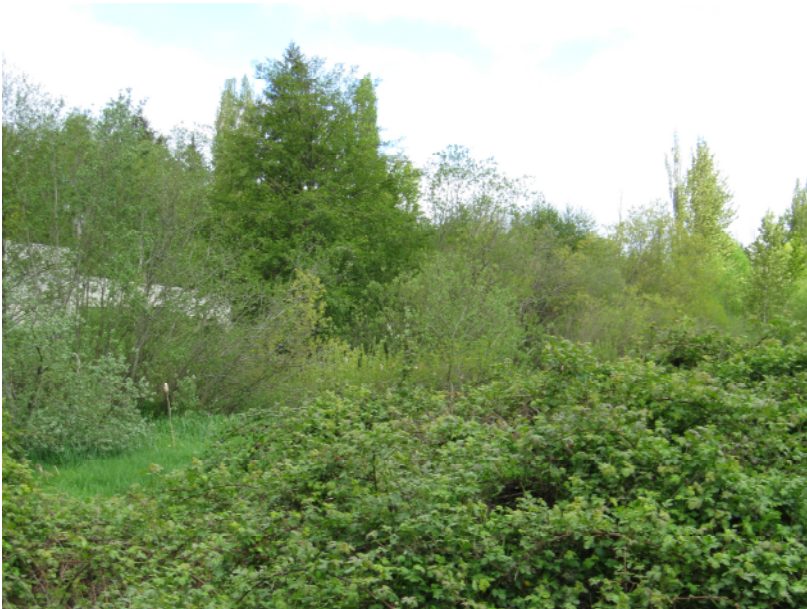
Photo ID: 031

Description: Miller Creek U/S wetland

Observations: U/S wetland is served by the arched culvert (030) above and is of described adequate capacity (as per Bob Pegnam).

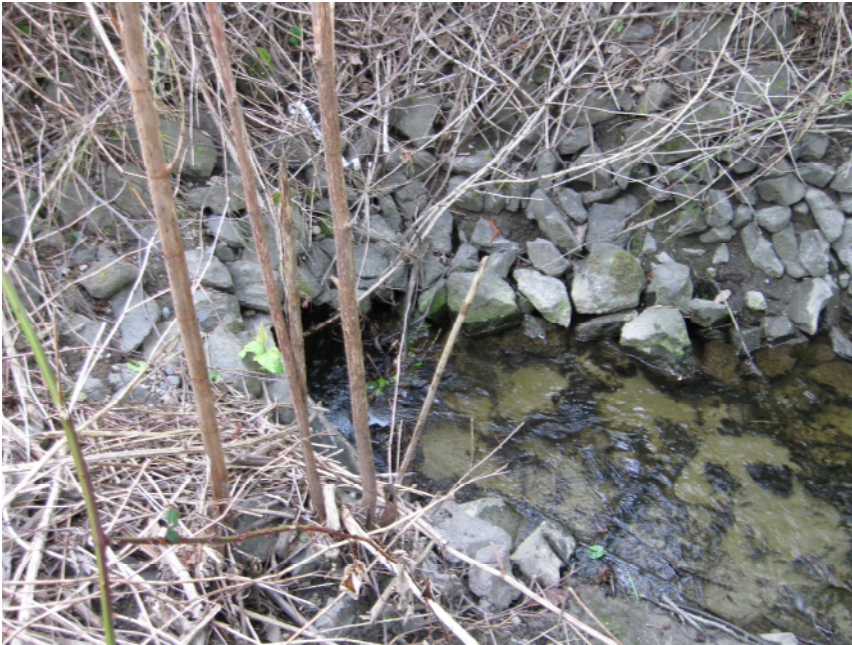
Photo ID: 037

Description: Miller Creek D/S wetland culvert

Observations: Reportedly undersized<sup>1</sup> culvert w/riprap. Approximately 2' diameter.

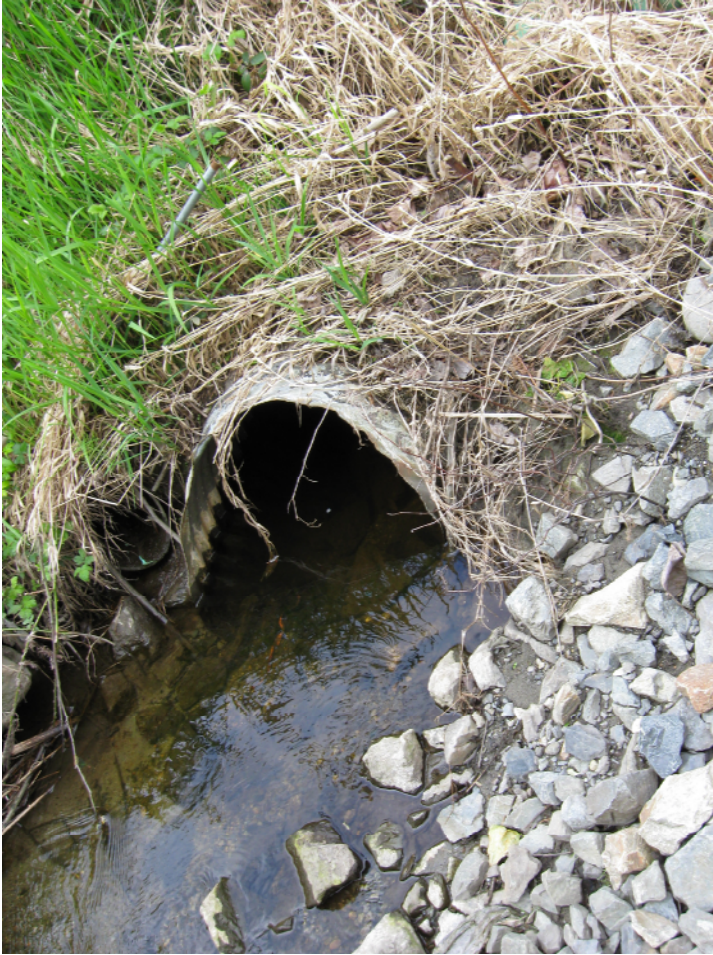
Photo ID: 038

Description: Miller Creek across Parking access road, U/S

Observations: Reportedly undersized<sup>1</sup> culvert with new bank stabilization implemented in the area. New plantings, woody debris present.

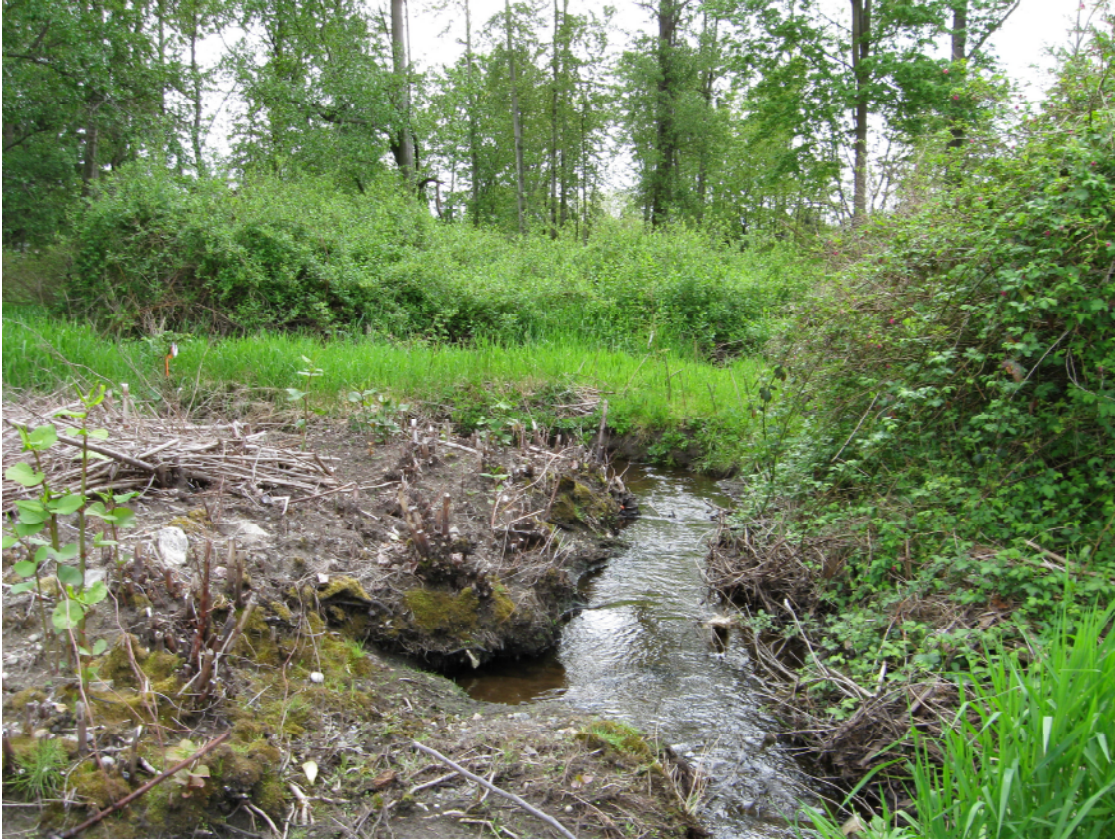
Photo ID: 039

Description: Miller Creek across Parking access road, looking D/S

Observations: Reportedly undersized<sup>1</sup> culvert with new bank stabilization implemented in the area. New plantings, woody debris present.

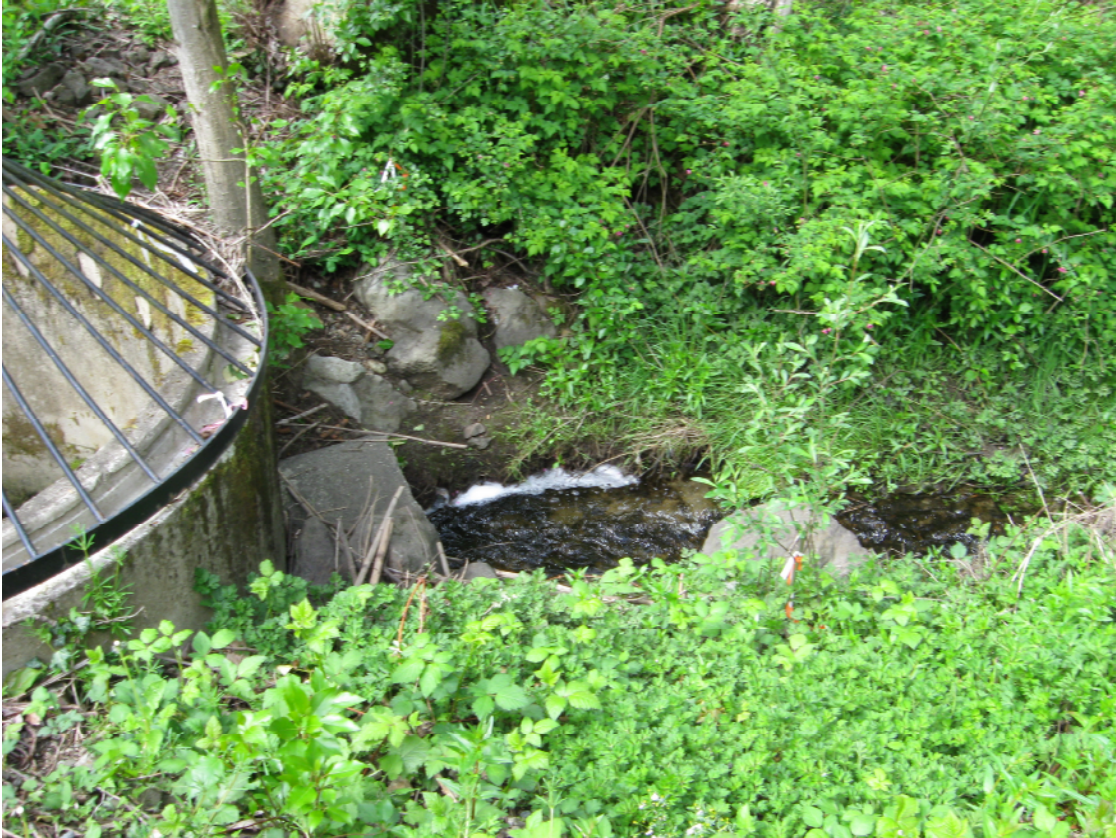
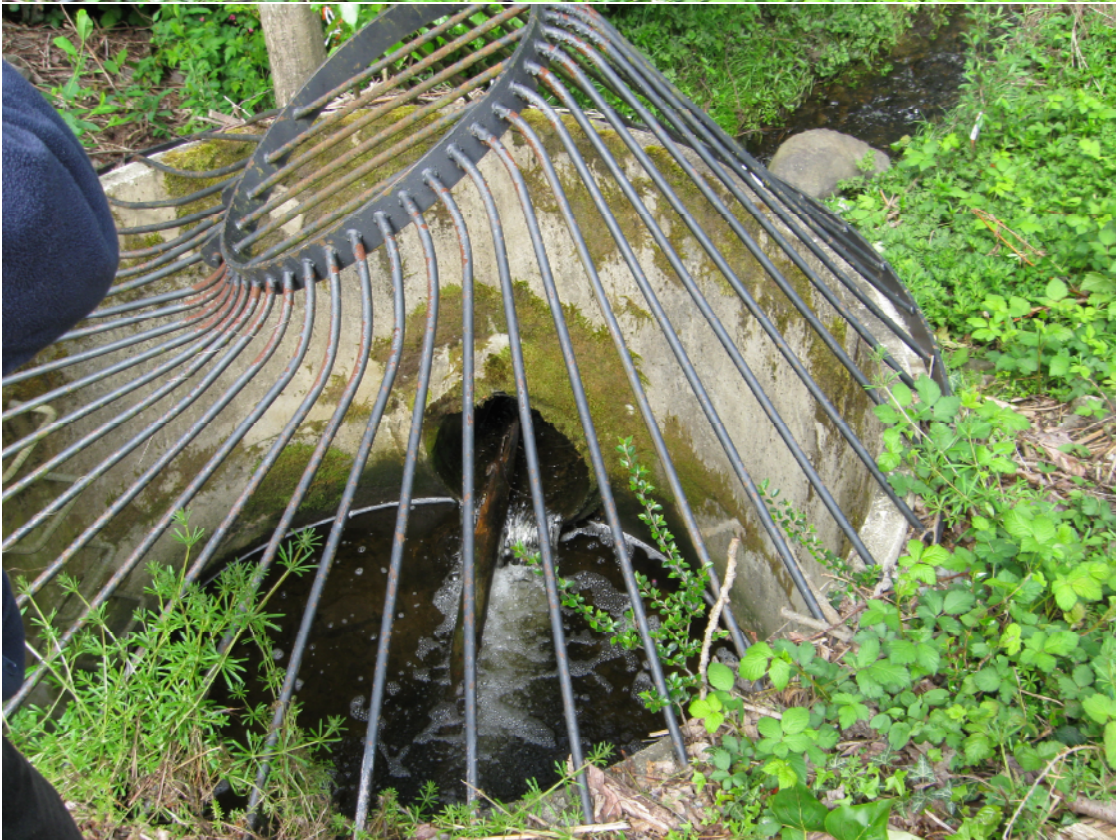
Photo ID: 040 and 041

Description: Wetland portion west of Des Moines Drive.

Observations: Reportedly undersized<sup>1</sup> pipe coming into the structure, but the outlet culvert is not undersized, for most rain storms.

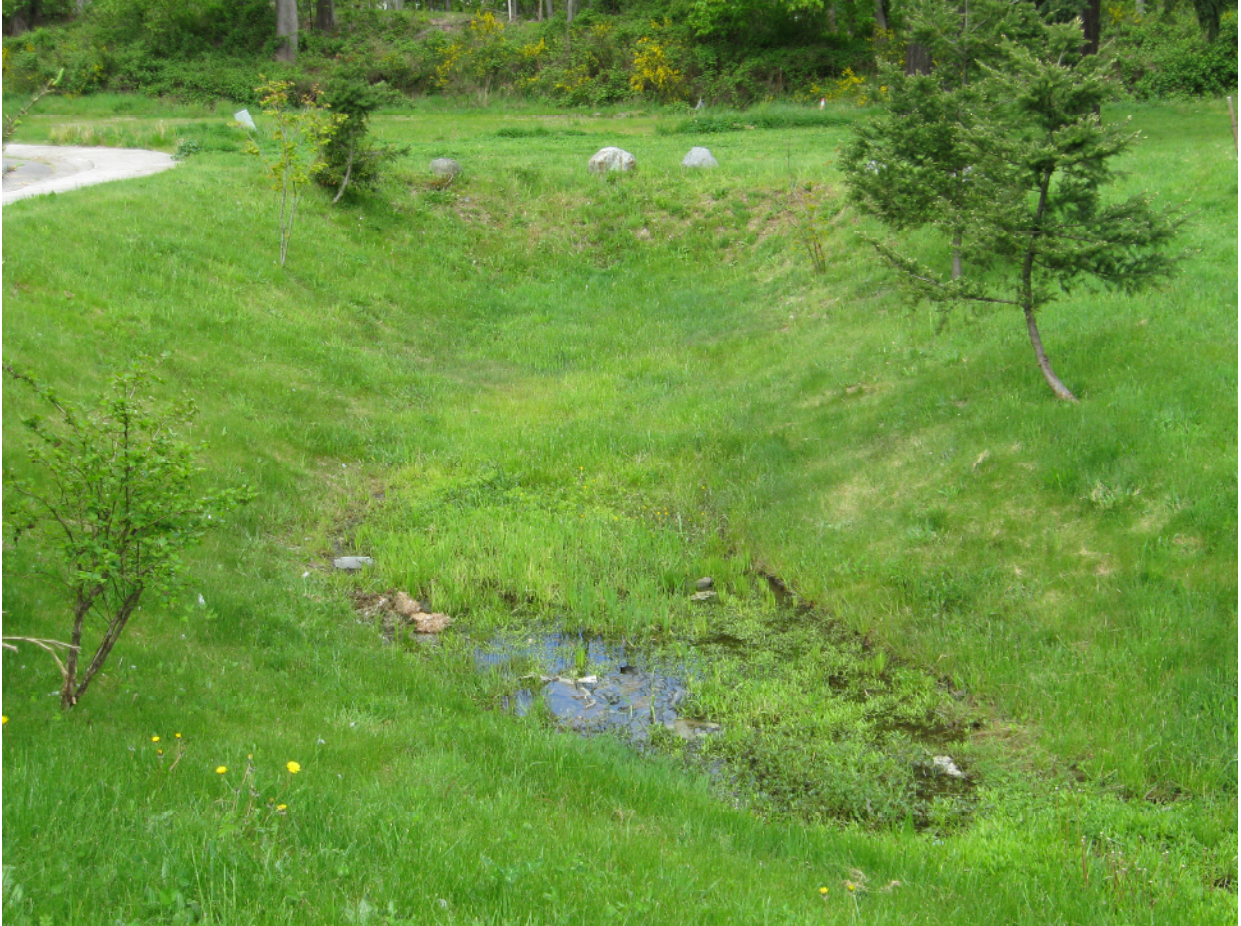
Photo ID: 050

Description: City of Burien Stormwater facility

Observations: Reportedly undersized<sup>1</sup> pipe into the birdcage structure for most rain storms.

Overflow volumes are dealt with by a large vegetated detention area located south of the wetland and west of Des Moines Drive.

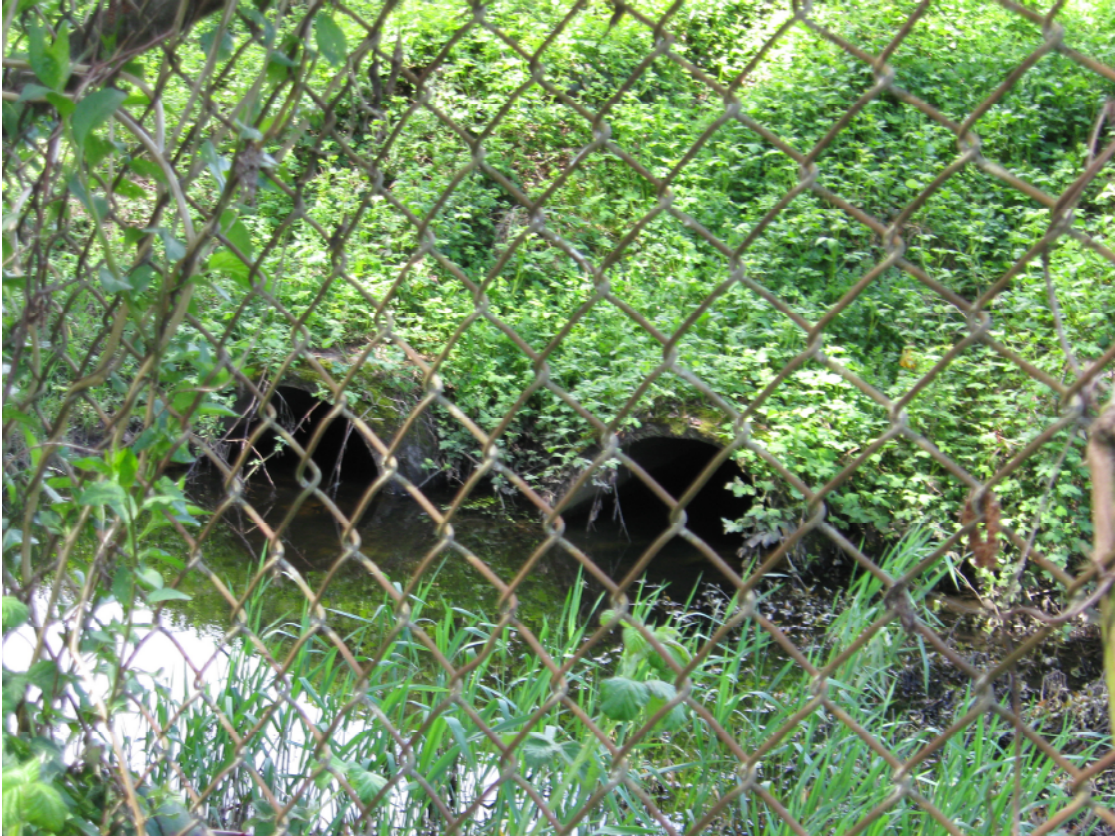
Photo ID: 059

Description: WSDOT right of way at SR 509

Observations: Two 4-ft diameter, reportedly undersized<sup>1</sup> culverts. During rain events flood the 30-ft D/S easement and onto the property. Have been evaluated to initiate the flooding of the Miller Creek region, causing most severe of damage D/S. Water quality also an issue. Remnants from last oil spill present, and are a constant issue as to the environmental integrity of the wetland.

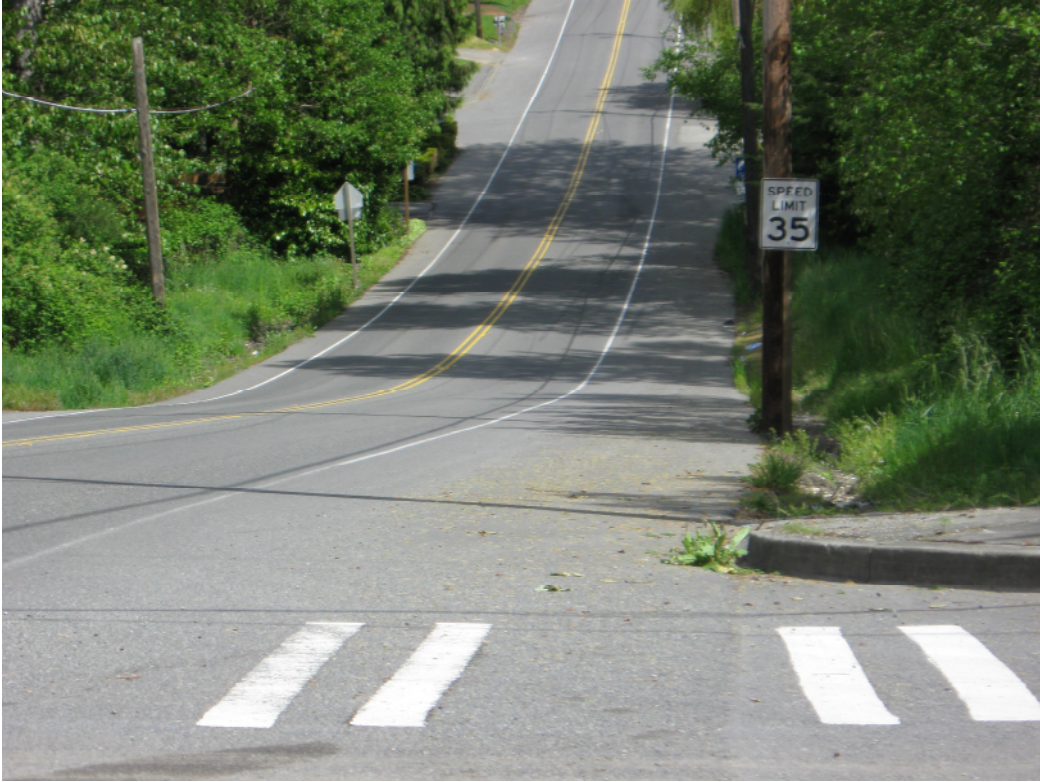
Photo ID: 062

Description: Looking North at 8<sup>th</sup> Ave

Observations: Catchbasin at 8<sup>th</sup> Ave. takes runoff from road North. No offsite drainage west of 8<sup>th</sup> Ave.

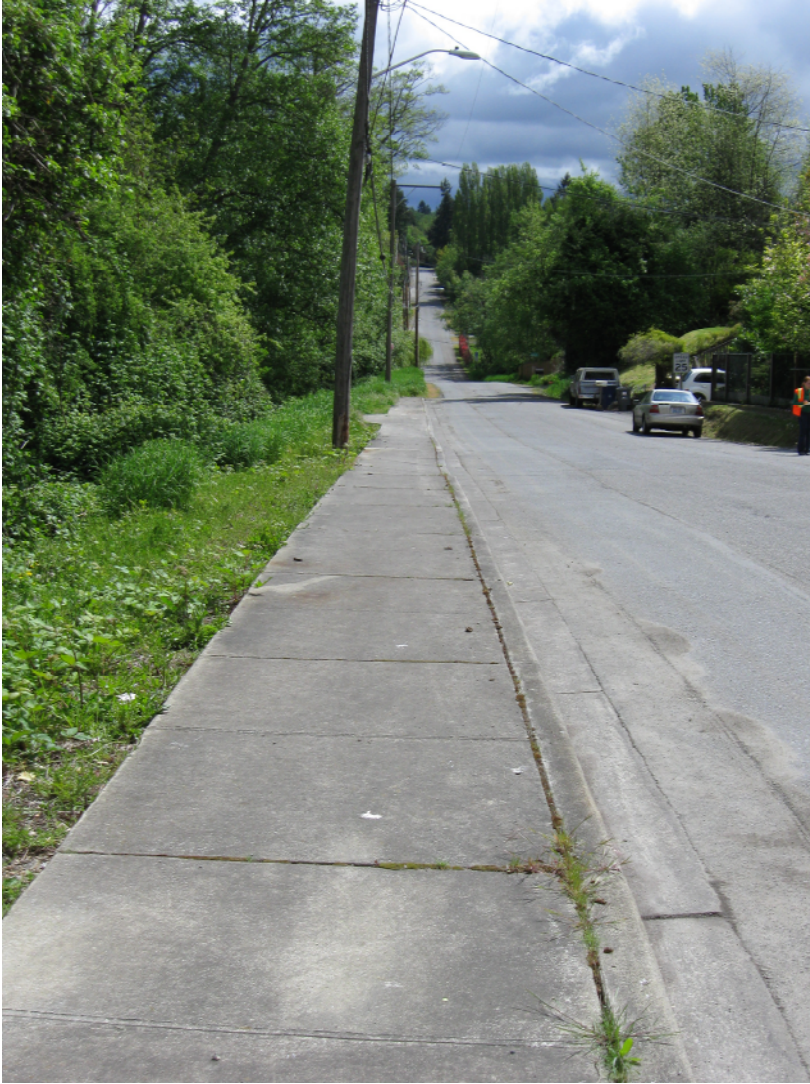
Photo ID: 064

Description: Lookin East on 140<sup>th</sup> St

Observations: Curb and sidewalk on North side of 140<sup>th</sup> for half of the street length. South side has ditches with storm pipe (8").

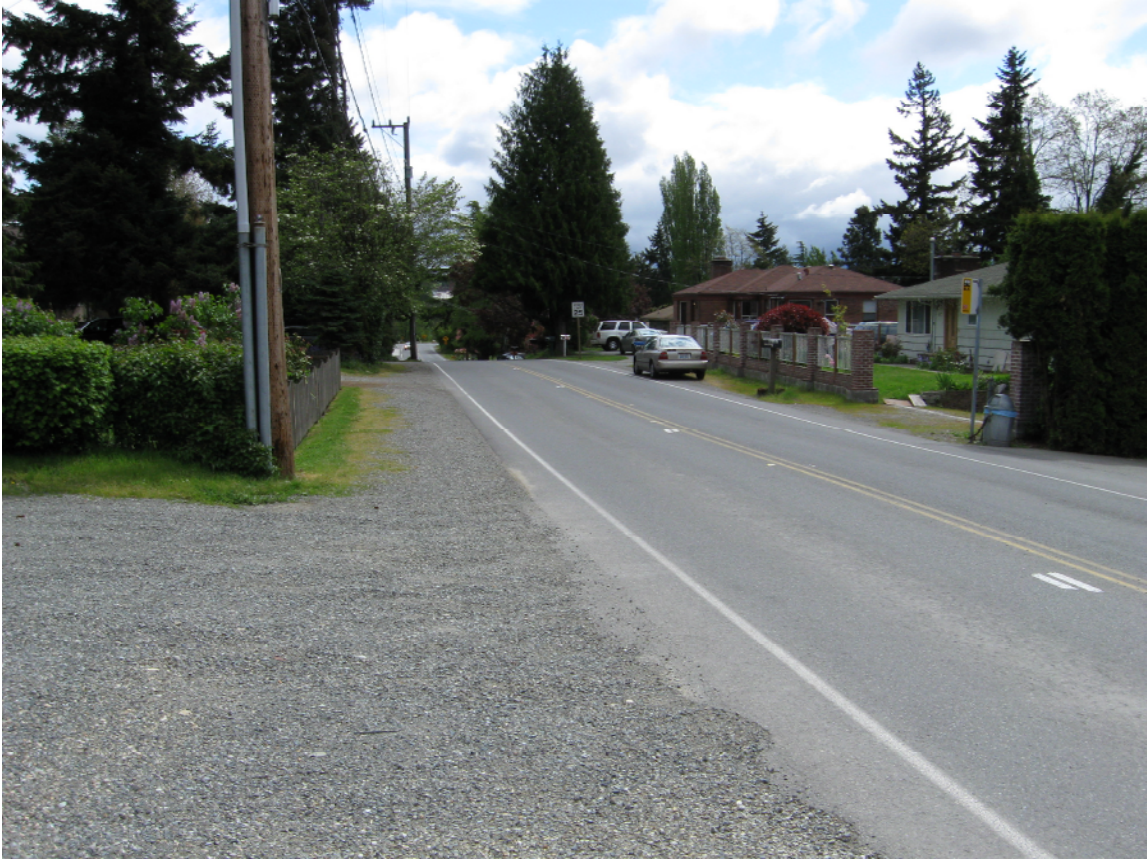
Photo ID: 068

Description: Looking East on 146<sup>th</sup> St

Observations: No curb or gutter, ditch by 8<sup>th</sup> Ave.
